DEPARTMENT OF ECOLOGY  
INSPECTION REPORT

*me*  
TO: Files, Dan Cargill  
DATE OF VISIT: 12/23/86  
NEW INDUSTRY:

FACILITY: Duwamish Shipyard, Inc.  
ADDRESS: 5658 W. Marginal Way  
CITY: Seattle ZIP 98106 COUNTY: King PH. NO. 206-767-4880

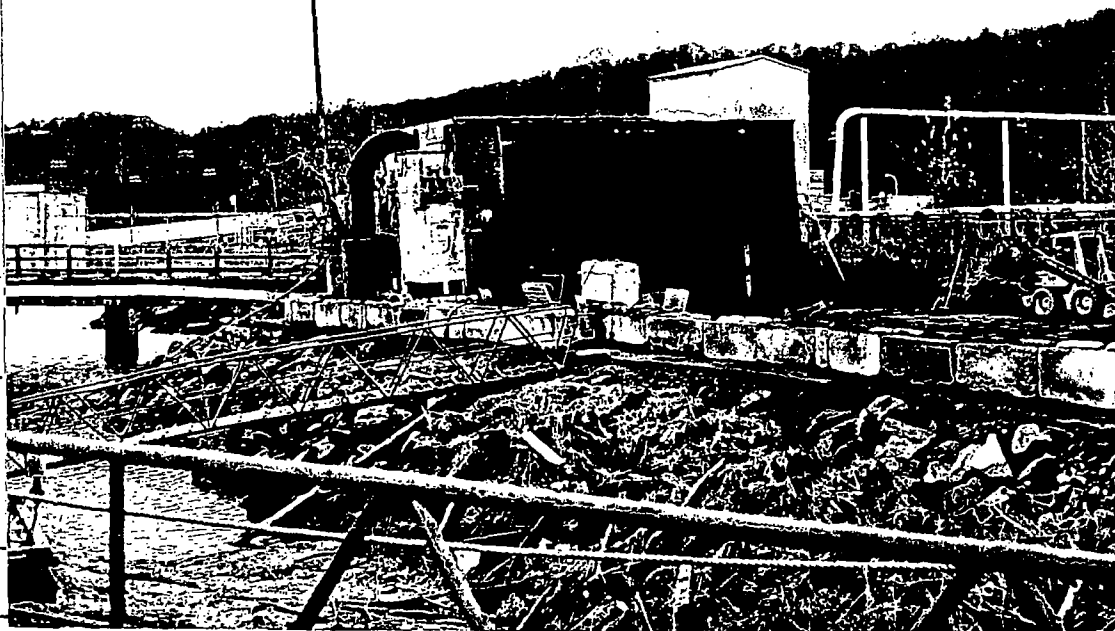
*Duramish  
Shipyard*

Drip pans have been placed on the docks in areas next to the drydocks. The sandblast shed walls were being finished during the visit with the plastic front partition scheduled for delivery in two weeks. Don pointed out the still for recycling solvents to the board and noted that this pollution control option is profitable for the company. Since purchasing the still they have lowered solvent consumption to about two 55 gallon barrels a year. Don also explained about the disposal options for sandblast grit.

*Sandblast shed.*

FOLLOW UP: 1. Check sandblast facility progress and barrel storage containment in Jan.
